# TEST REPORT INITIAL TYPE TESTING ITT-15.28 / 28.01.2016

Product: Window aluminum profiles "VIVA ALUMINIUM SYSTEMS"

Opening system with thermal break TBO 55

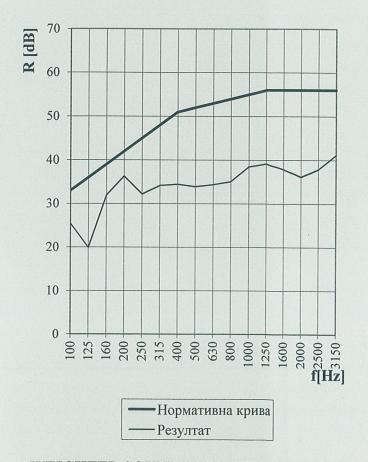
f, Hz	100	125	160	200	250	315	400	500	630	800	1000	1250	1600	2000	2500	3150
R, dB	25,4	19,9	31,9	36,3	32,6	34,2	34,5	33,9	34,4	35,1	38,5	39,2	37,9	36,2	37,9	41,2

WEIGHTED SOUND REDUCTION INDEX

Rw (C;  $C_{tr}$ ) = 37 (-1; -2) dB
